The Best Dam Team
Gonzaga University School of Engineering and Applied Science
502 E Boone Ave
Spokane, WA 99258
December 2nd, 2020

ENSC 24- Design and Evaluation of Beaver Dam Analogues

Status Report

THOMPSON CREEK BEAVER DAM ANALOG STREAM RESTORATION PROJECT STATUS REPORT

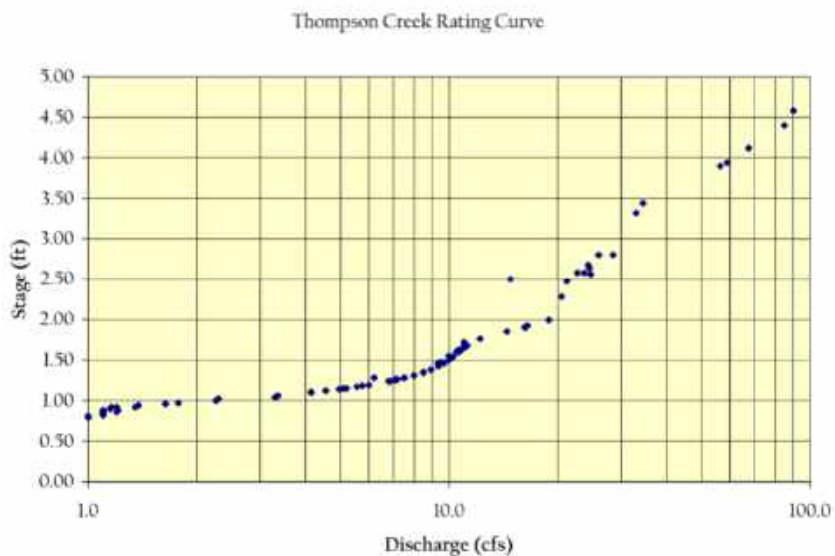
Figure 5: Thompson Creek Rating Curve (Spokane Department of Ecology)

TBDT is continuing to collect and analyze data related to the characterization of watershed and reach scale processes in Thompson Creek that might go beyond the work being completed by CENG 426 and described in the monitoring plan. TBDT questioned the accuracy of the existing flow rating curve (Figure 5) at Thompson Creek that was established prior to the construction of NW Newman Lake Rd. Bridge on the upstream end of the reach. The accuracy of the staff gauge (Figure 6) and accompanying rating curve is in doubt because there has been significant sediment build up on the stream gauge upstream of the bridge (~1.8 ft of sediment). TBDT performed a site visit to measure stream flow and depth where the stream gauge is located to compare to the rating curve. The results said the streamflow measurement found a flow of 1.8 cfs with a thalweg depth of 1.4 feet. When using the staff gauge on the same day, the depth was read as 2.4 feet correlating with a flow from the rating curve of almost 20 cfs. It is evident that the stream staff gauge is providing inaccurate readings and cannot be used currently to evaluate flow in Thompson Creek. Upon further discussion with colleagues from Spokane County Department of Ecology, it is assumed that the stream staff gauge and rating curve were accurate prior to the construction of the new bridge; however, it is hypothesized that the bridge widened the channel and caused sediment to aggrade and build up on the staff gage. As a result, the stream staff gauge cannot be used to measure flows, and TBDT will need to measure flow manually if a flow measurement is of necessity.

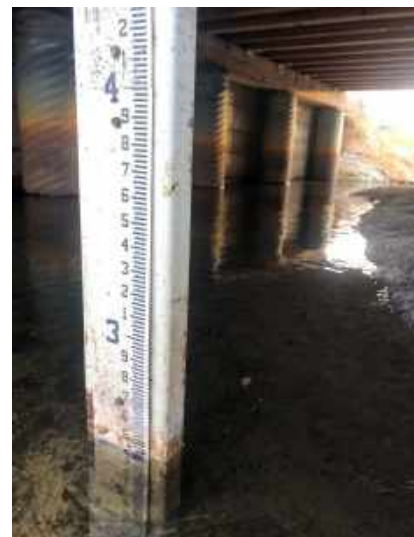
Figure 6: Thompson Creek Stream Staff Gauge

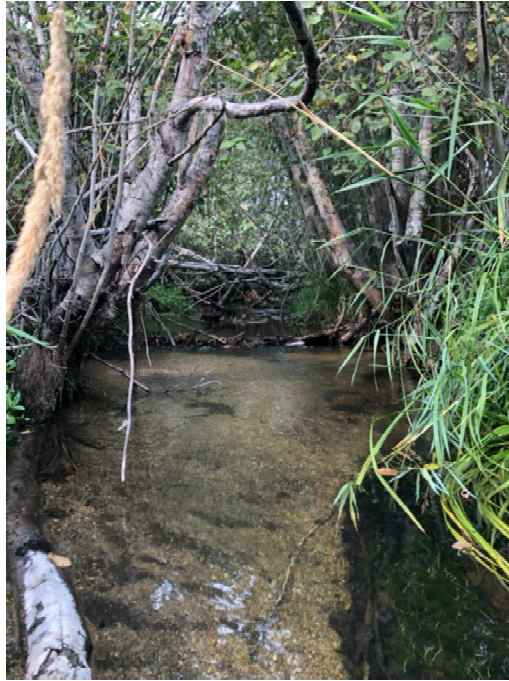
Figure 8: A View upstream at Thompson Creek from our visit on September 24th

- **September 24th, 2020:** Site walkdown including marking cross sections, establishing data collection objectives and locations, and collection of the first of 12 water samples for baseline data collection

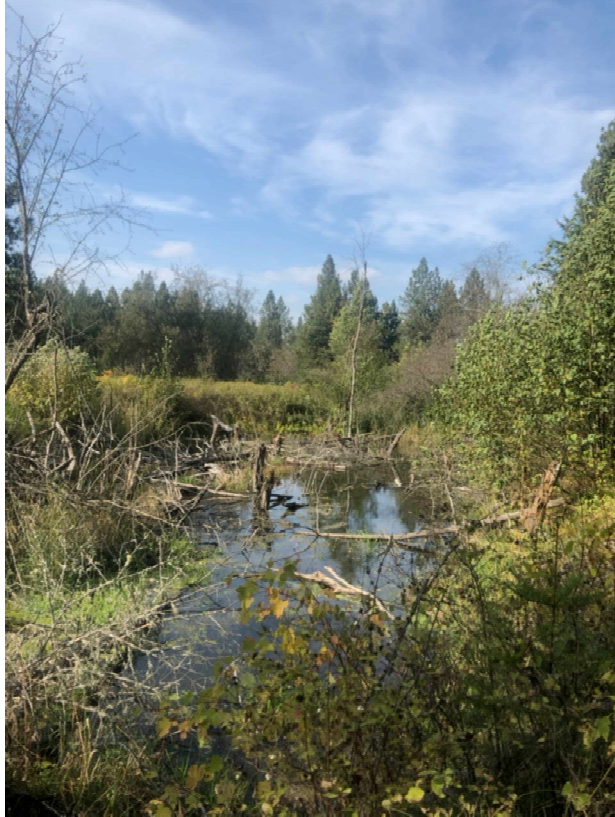
Figure 10: A picture of a natural beaver dam at Liberty Lake taken during our October 8th visit

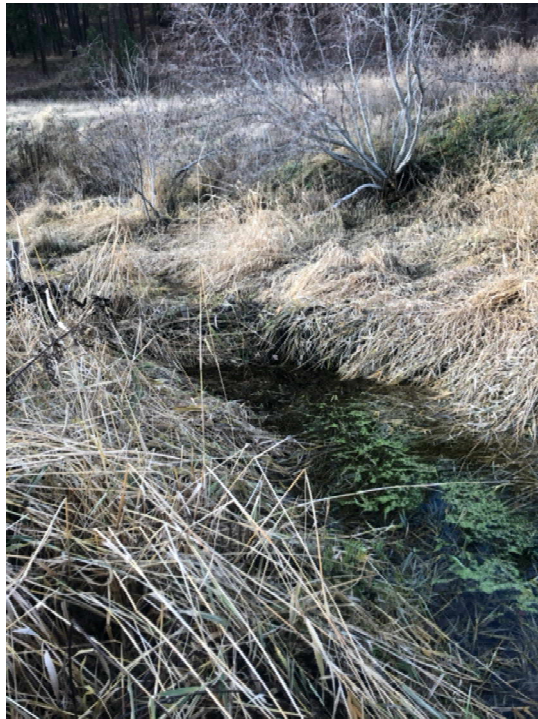
Figure 11: A BDA at California Creek taken during our visit on November 19th

- **November 19th, 2020:** TBDT and the CENG 426 Class visited a BDA complexes at Rattler Run Creek and California Creek to observe what they look like and how they function.
